No. 1462167.6

SAMPLE DESCRIPTION:
HARO Oak Engineered Timber Flooring with Selleys
Timber Flex adhesive applied in the joints and fixed to a
Perspex.
Oak Markant Plank 1-Strip 180

**ISO 4760:2022(E) - LAMINATE FLOORING – TOPICAL MOISTURE RESISTANCE – ASSEMBLED JOINT
(MODIFIED)**

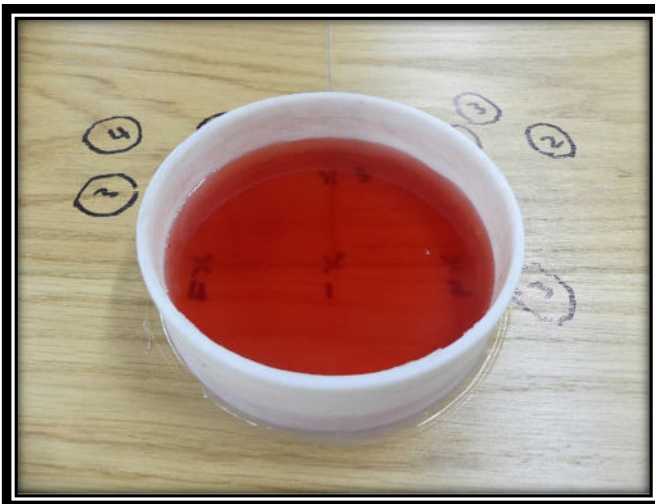
After 24 Hrs with Water

100 mls of dye solution was applied onto the sample surface. It was poured into a cylinder 100mm diameter placed in the centre of the sample at the "T joint." Sealant was used at the plank/cylinder interface to avoid leakage.

The sample was left at 20°C, 65% Relative Humidity room conditions for 24 hours after the dye was added and then examined for dye penetration through the backing (not 23°C, 50% RH as stated in the method).
